RESEARCH PAPER

Evaluation of Full-Scale Concrete Frames Exposed to Natural Fires at Early Ages.

ZJPAS (2020) , 32(2):115-128 .

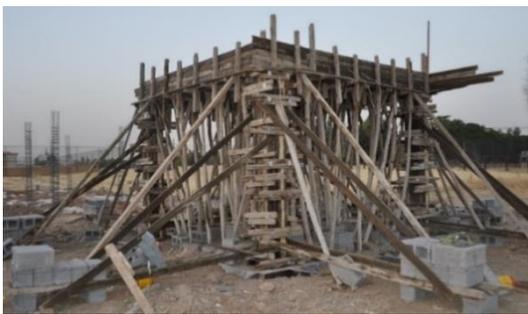
The test program consisted of casting three frames of reinforced concrete, which has the same dimensions. These dimensions are shown in Figure 1; the column cross-section was 300×300 mm; the beam width was 300 mm, 300 mm dropped below the slab; and the slab thickness was 120 mm. The span of the frame in both directions between the center of the columns was

4000 mm, and the height of the column was 3000 mm. The test frame was supported on four single column footings built specifically for this purpose.

Figure 1: Dimensions of frame structure

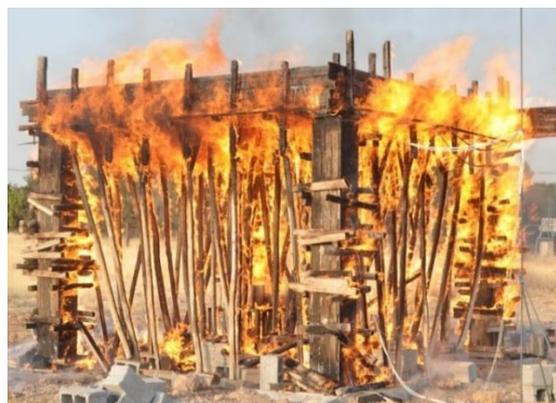
Figure 4: Reinforced concrete frame exposed to fire

After creating a wooden mold for the concrete frame, then cast with concrete. The concrete curing process began and continued until the concrete age was three days for FF3 and five days for FF5. Then the wooden mold of the reinforced concrete frame was burned, as shown in Figure 4. The temperature of the inside concrete was increased after the wooden mold was burned. The measuring temperature inside the concrete was done by inserting k-type thermocouples into the mold before casting, as shown in Figure 5. A total of 11 number of embedded thermocouples were used and secured in place before the casting of concrete. The location of the thermocouples is shown in Figure 6.

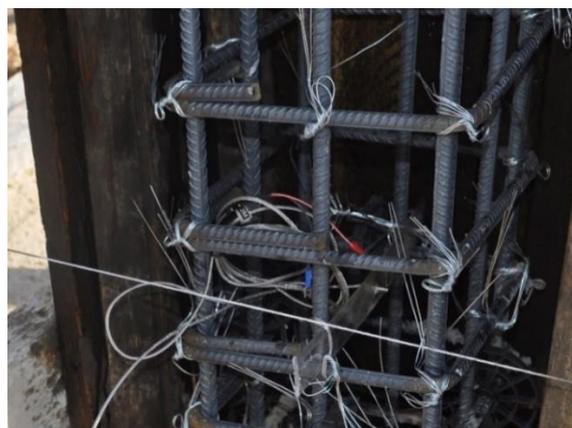
Figure 5: Insertion of a thermocouple

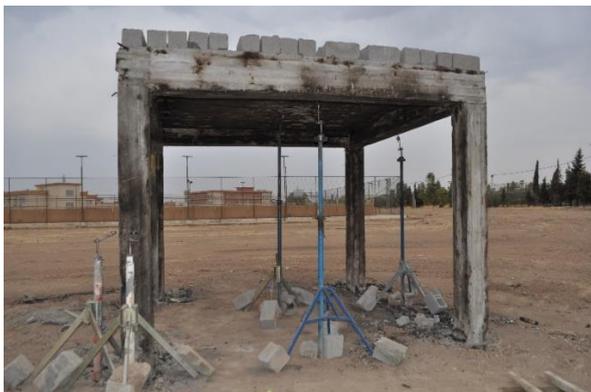
stands and set below the slab & beams and beside of column. The first dial gauges were installed at the center point of the slab, and the second and third dial gauge was mounted in the middle of the two beams, while the fourth and fifth dial gauges were installed beside the column in two directions and at mid-height as shown in Figure 13.

Figure 13: Location of installed dial gauges

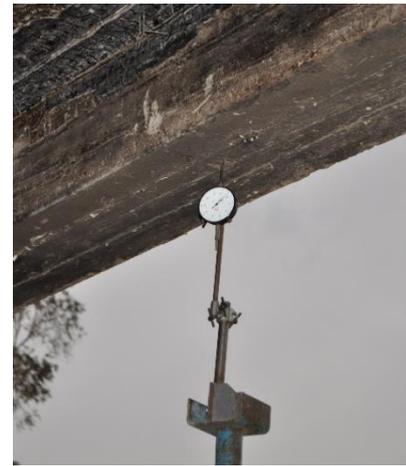
Figure 14: Installation of dial gage by using the magnetic base

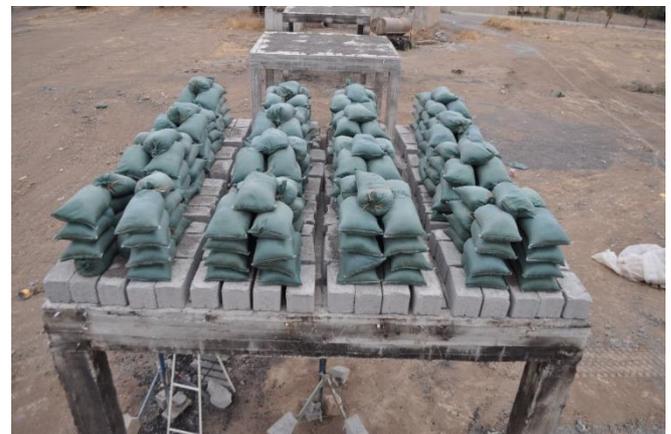
Figure 14: Applying full load by using sandbags

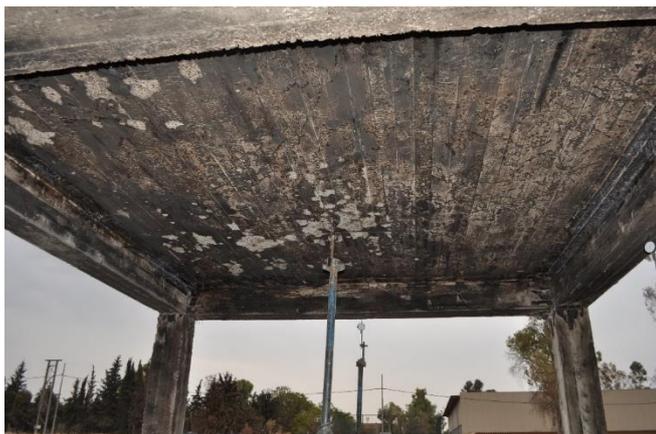
Spalling begins to occur when the concrete reaches an elevated temperature of 250 °C. From 250-420 °C, some spalling occurs. After reaching 300 °C, concrete starts to lose its strength. Within 550-600 °C, cement-based materials experience creep and lose their load-bearing capacity (Iffat and Bose, 2016). As shown in Figure 16, despite the observed surface spalling at the bottom of the slab, the test frames did not suffer any significant spalling (loss of big chunks) of concrete or loss of cover (exposing reinforcement) at any location in the test frame.

Figure 16: Spalling and change color occurred in slab

After exposing the reinforced concrete frame to the natural fire by burning its wooden formwork, the inner face color of the frame was black due to wood smoke, but no major change in the color of concrete itself was observed as shown in Figure 16.
